# Understanding the impact of defects on the properties of MoS<sub>2</sub>

December 22 2017

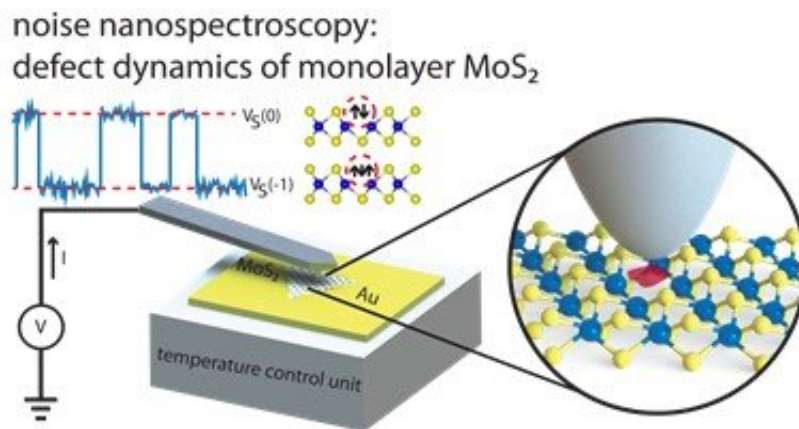
The study on 2-D molybdenum disulfide (MoS<sub>2</sub>) defects employed low frequency noise measurements and conductive atomic force microscopy (C-AFM). The enlarged image shows an AFM cantilever tip pointing to an area with one sulfur monovacancy (area shaded red). As current flows through the AFM tip and the sample, switching events between different ionization states (neutral and charged -1) are measured. With a radius of around 25 nanometers, the AFM tip covers an area that contains around 1-8 sulfur monovacancies. Credit: IBS, published on *Nature Communications*

In IBS, a team of physicists, material scientists, and electrical engineers worked closely together to explore the electronic properties of sulfur vacancies in MoS<sub>2</sub> monolayers, using a combination of atomic force microscopy (AFM) and noise analysis. The scientists used a metallic AFM tip to measure the noise signal, i.e., the variation of electrical current passing through a single layer of MoS<sub>2</sub> placed on a metal substrate.
