# Promising results for eelgrass restoration using sand-capping

December 15 2021, by Anna Brodin

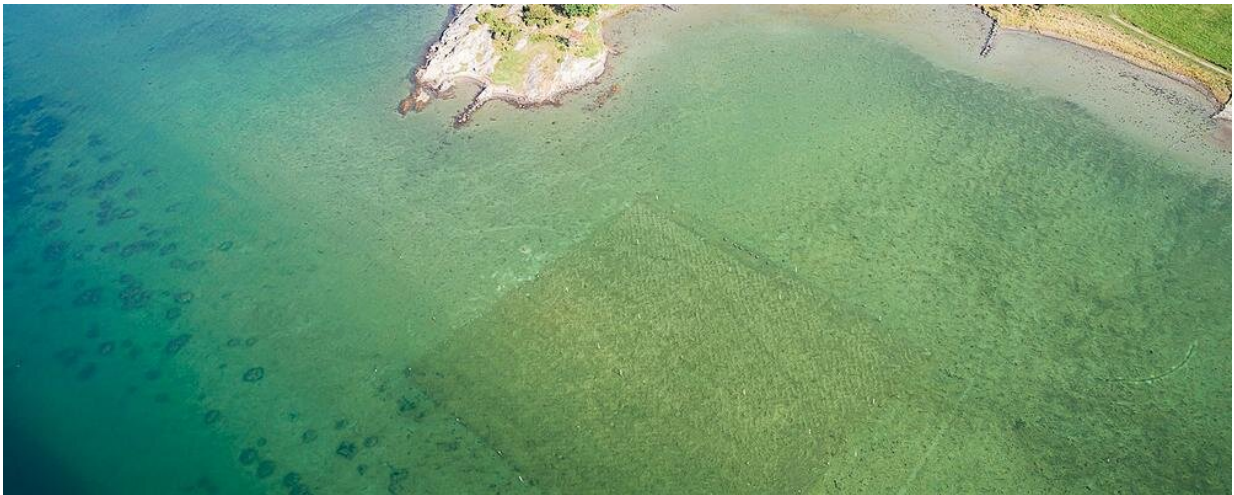
This summer, divers planted 80,000 eelgrass shoots at the sand-capped area at Lilla Askerön. A follow-up study now shows that the eelgrass shoots have survived and reproduced to a total of 176,400 shoots. Credit: Eduardo Infantes

During the summer, divers planted 80,000 eelgrass shoots in the sand. The follow-up study now shows that the eelgrass shoots have survived and reproduced to a total of 176,400 shoots. Also test sites outside the sand-capped area show a good survival rate.

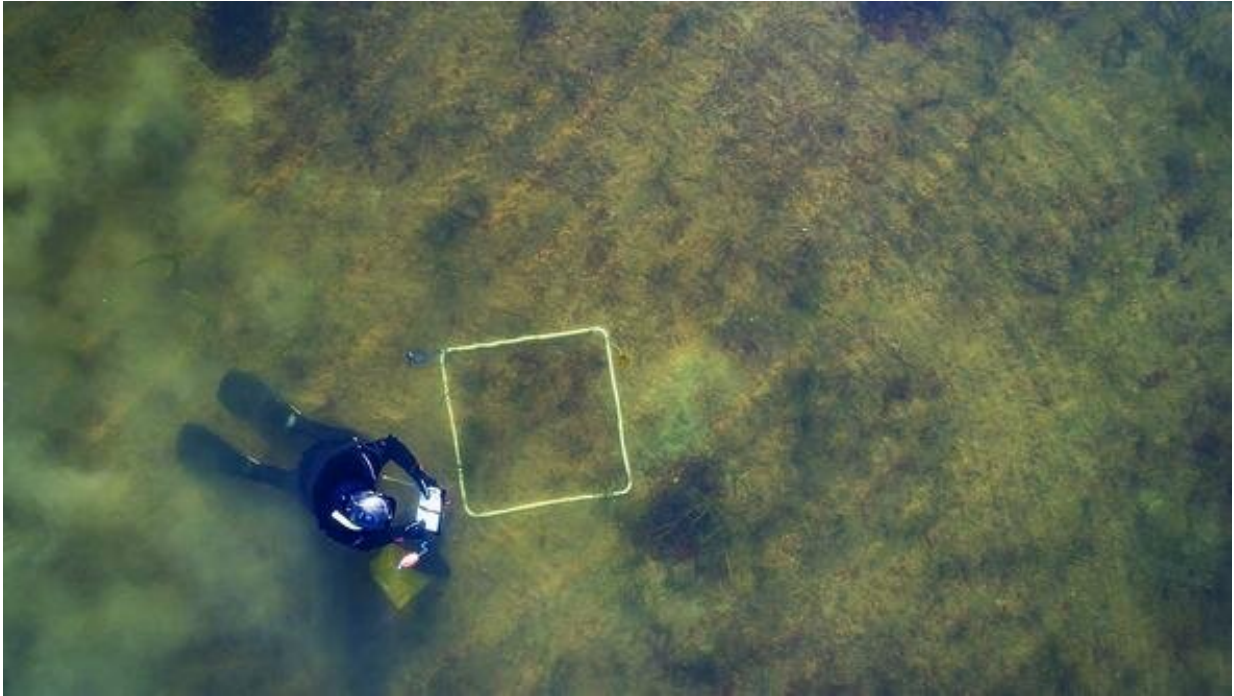
This autumn's inventory of the 10,000 square meter planting area showed that the number of eelgrass plants had more than doubled. Credit: Eduardo Infantes

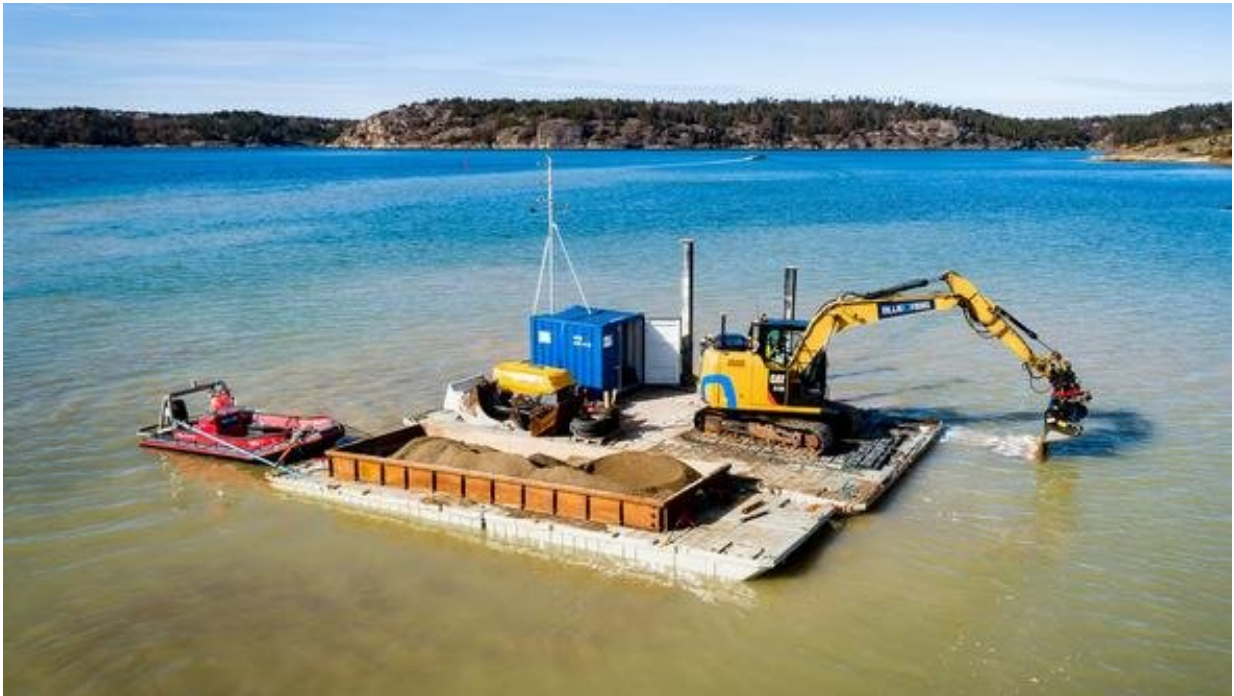
In the spring of 2021, a total of 1,800 tonnes of coarse sand was spread in the bay at Lilla Askerön. Credit: Eduardo Infantes

An area where the water easily becomes turbid, is the southern bays at Lilla Askerön outside the island of Tjörn. To reduce the turbidity from the muddy bottoms, and to improve light conditions in the water, the County Administrative Board and the University of Gothenburg had excavators cover one hectare of the seafloor with a ten centimeter thick layer of coarse sand. This method of sand-capping the bottom is new in Sweden, but has been tested successfully in for example Denmark.
