2013 Colorado front range flood: Debris-flow a major hazard

September 29 2014

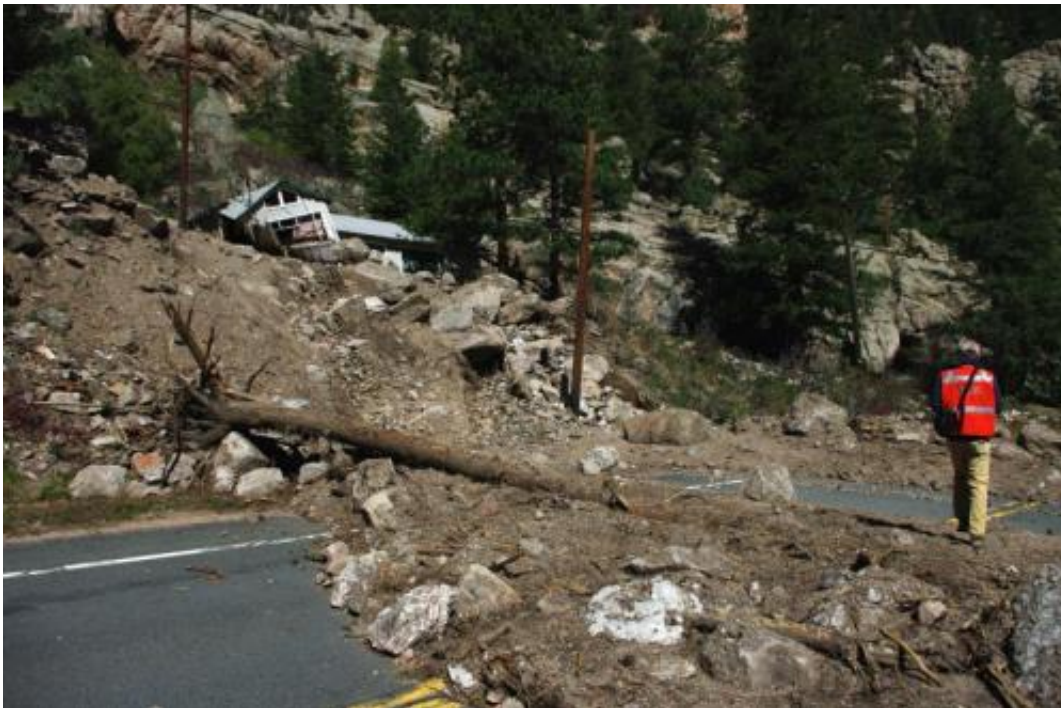
House damaged by a September 2013 debris flow in Big Thompson Canyon in the Colorado Front Range; deposit (foreground) covers US Highway 34. Credit: Jonathan Godt / GSA Today

Between 9 and 13 September 2013, more than 1,100 debris flows occurred in an area of about 3,400 square kilometers, most of which were triggered by two periods of intense rainfall: one lasting 12.5 hours on 11–12 September, with a maximum 10-minute intensity of 67 mm/hour, the other lasting 8 hours on 12 September, with a maximum intensity of 39 mm/hour.

Almost all of the flows were initiated on steep (greater than 25 degrees), south- and east-facing canyon and hogback slopes with upslope contributing areas of more than 3,300 square meters, the largest at elevations above 2600 m. Areal concentrations of the flows show that colluvial soils on sedimentary rocks were more susceptible than soils on crystalline rocks.
